CLEVELAND HISTORIC PRESERVATION MANUAL

Guidelines for Owners and Residents

Prepared by: David Preziosi, AICP - Mississippi Heritage Trust

**CLEVELAND, MISSISSIPPI
2008**

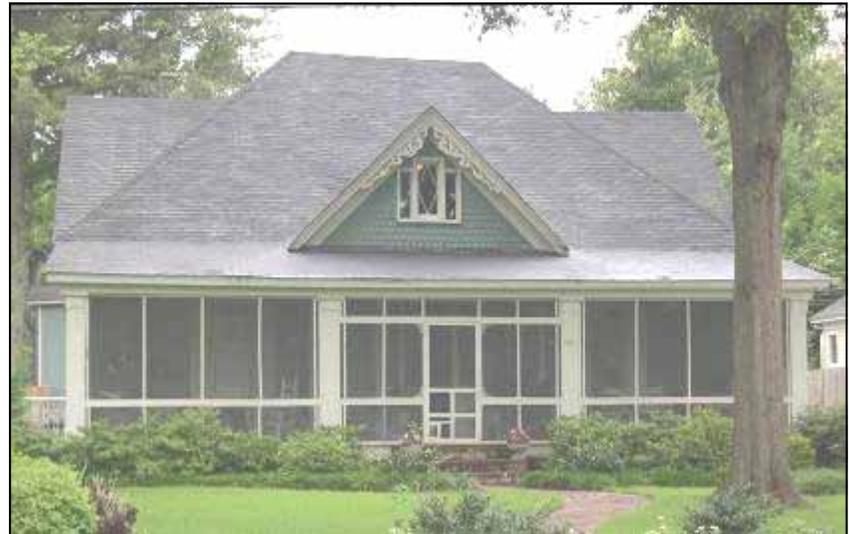
The original columns at 210 South Bolivar Avenue were most likely turned and later replaced with box columns.

A number of the houses built in the Queen Anne style in Cleveland have had modifications over the years mostly to their porches as columns were replaced with those in the current popular style or simple inexpensive box columns.

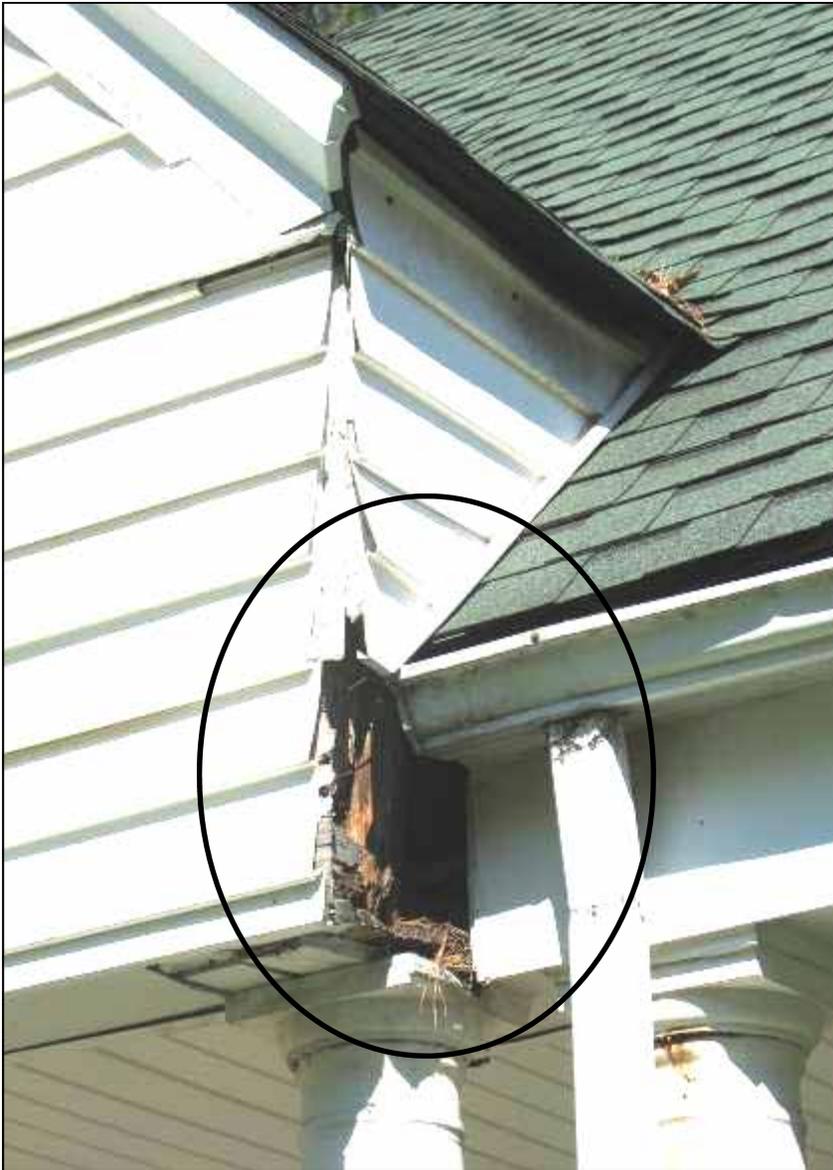
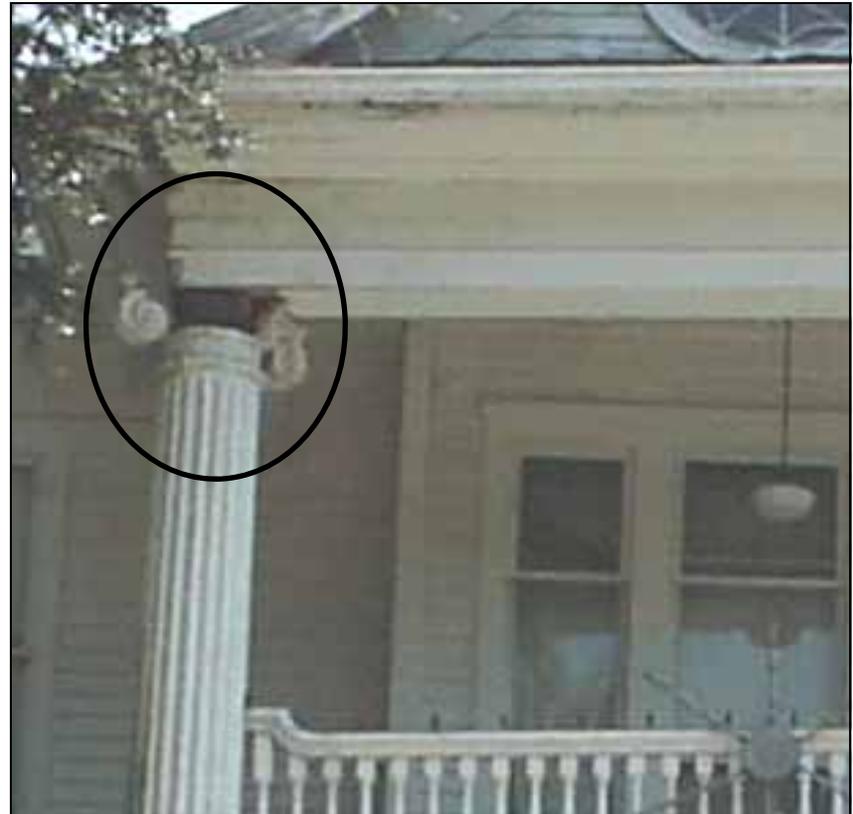
The photo on the left shows the dangers of applying vinyl siding to historic buildings. The siding can trap moisture which can lead to rot which is not easily visible. This rot was not discovered until the vinyl siding fell off the house exposing the problem area. Vinyl siding should be removed or inspected regularly to make sure water is not getting behind it and causing damage to the wood structure of the house. Below is an example of the failure to clean and maintain gutters which is the primary cause of porch deterioration such as the damage caused to the column capital.

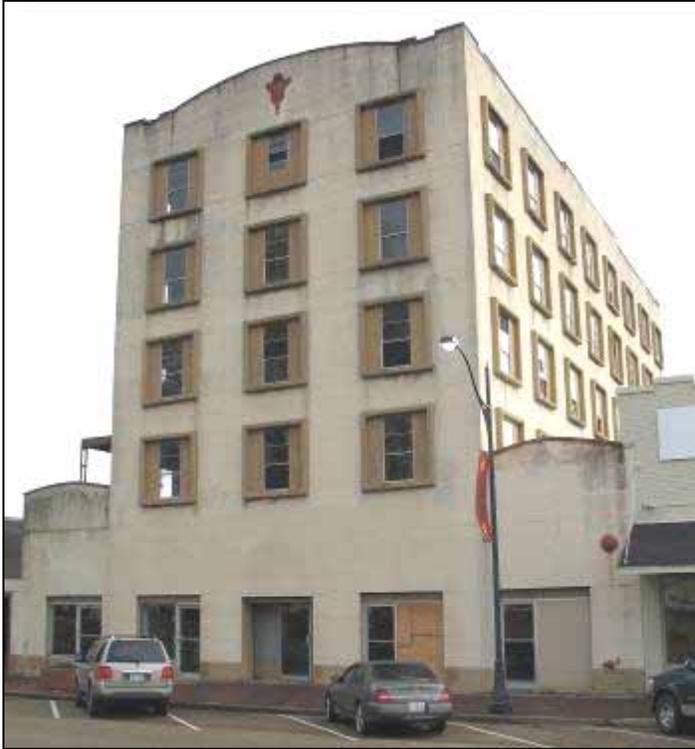
The original brick exterior of the Grover Hotel in downtown Cleveland was covered with stucco and scored to look like large blocks.

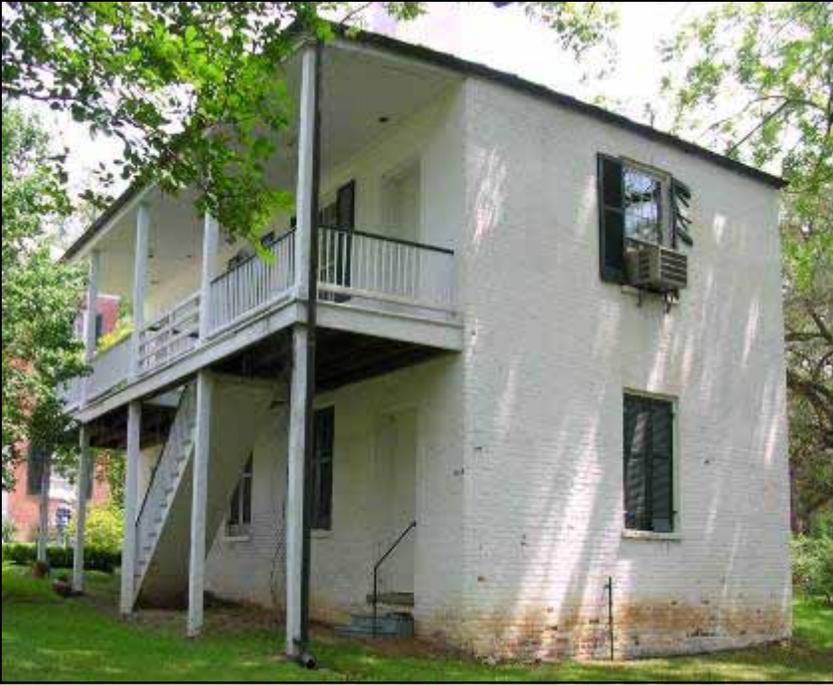
This kitchen building behind a historic mansion in Natchez shows the effects of rising damp along the base of the building. Water running along the façade and pooling at the base of the side elevation is the source of the problem. Controlling water run-off and preventing the pooling of water will correct the problem.

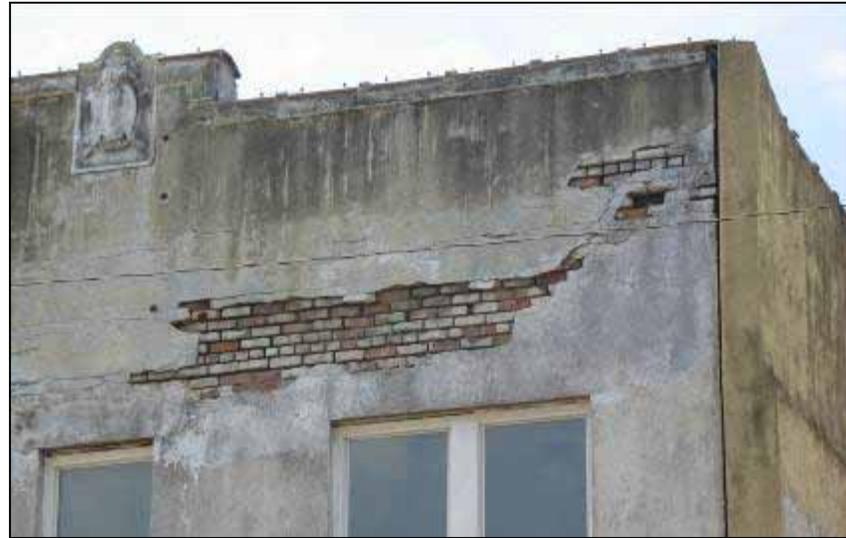
This building is suffering from falling damp most likely from water that is infiltrating at the top of the parapet and causing the noticeable stucco discoloration at the top of the wall and the problems with the stucco losing its bond with the brick below and falling off of the building.

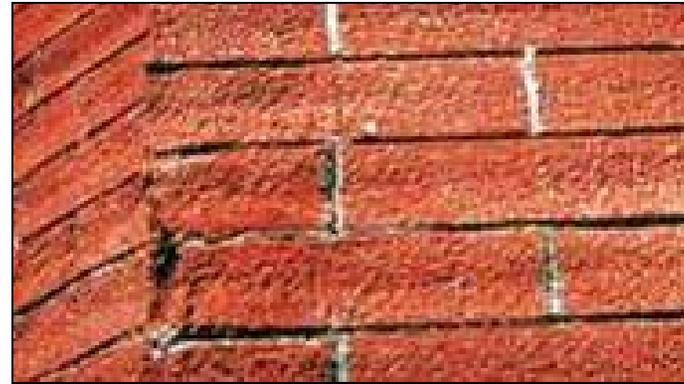
This National Park Service photograph well illustrates the negative effects of sandblasting, which should never be used to clean brick buildings. Sandblasting will not only erode mortar but will also remove the glazed outer surface of brick and hasten deterioration.

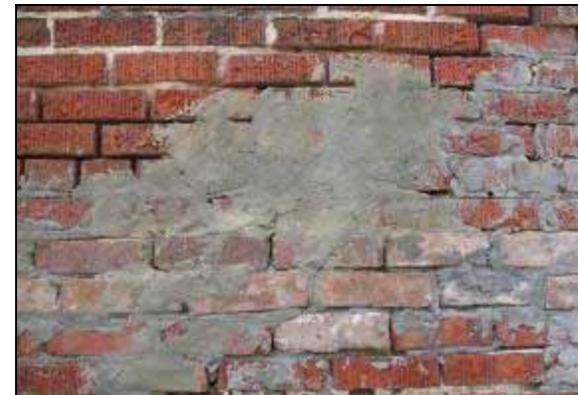
The owner of this brick building tried to stop the mortar erosion and water infiltration by smearing concrete over the deteriorated areas. This makes it very difficult to properly repair the problems in the future and has caused more damage to the brick surface

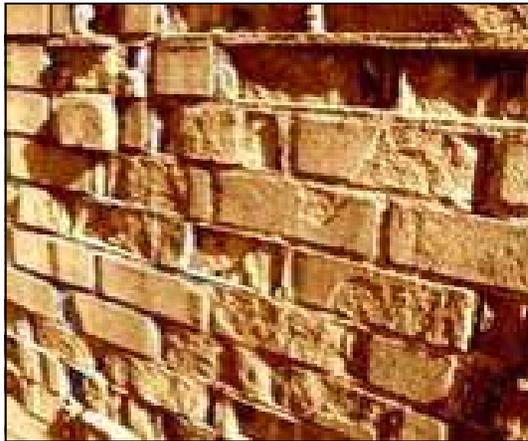
This photograph supplied by Chagrin Falls Preservation in Ohio illustrates the spalling that can occur only five years after using portland cement mortar in repointing.

Using a mortar that is too hard, like portland cement, will cause cracking and spalling (surface erosion) by preventing bricks from expanding and contracting with changes in temperature and humidity. To match the color of mortar for repointing, samples need to be laid up weeks before work begins to allow for color changes in drying.

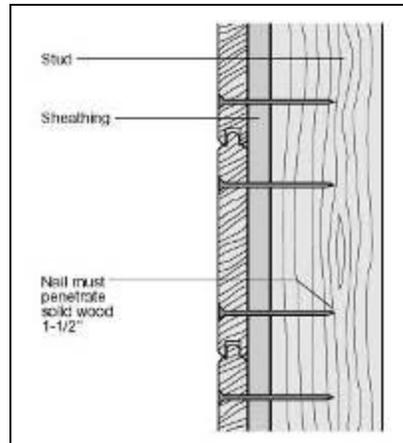
Tongue-and-groove siding

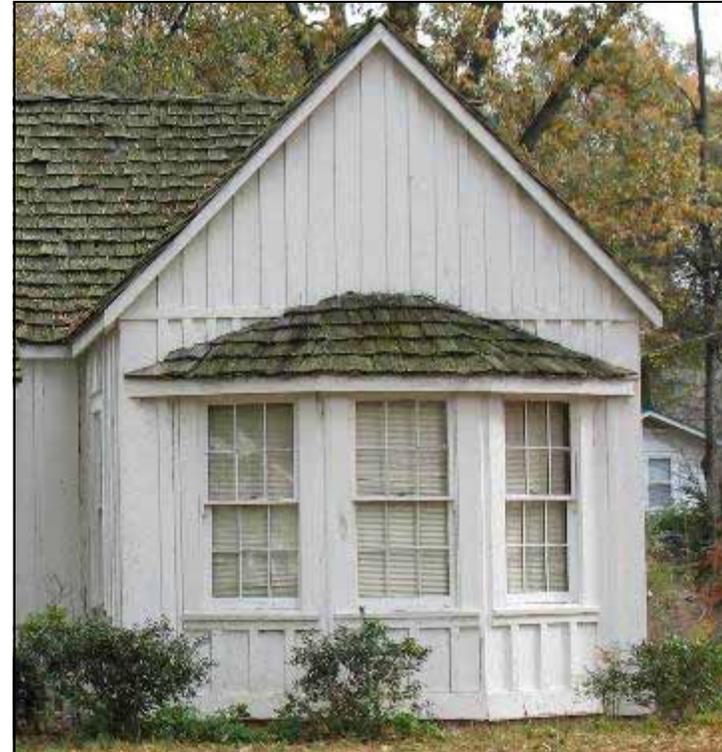
The house at 209 South Victoria Avenue uses board-and-batten siding.

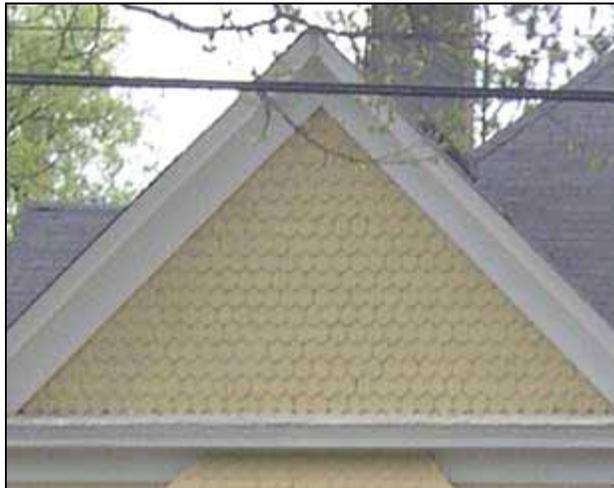
212 South Bolivar Avenue uses a rounded shingle siding in the gable, commonly known as a Fish Scale pattern.

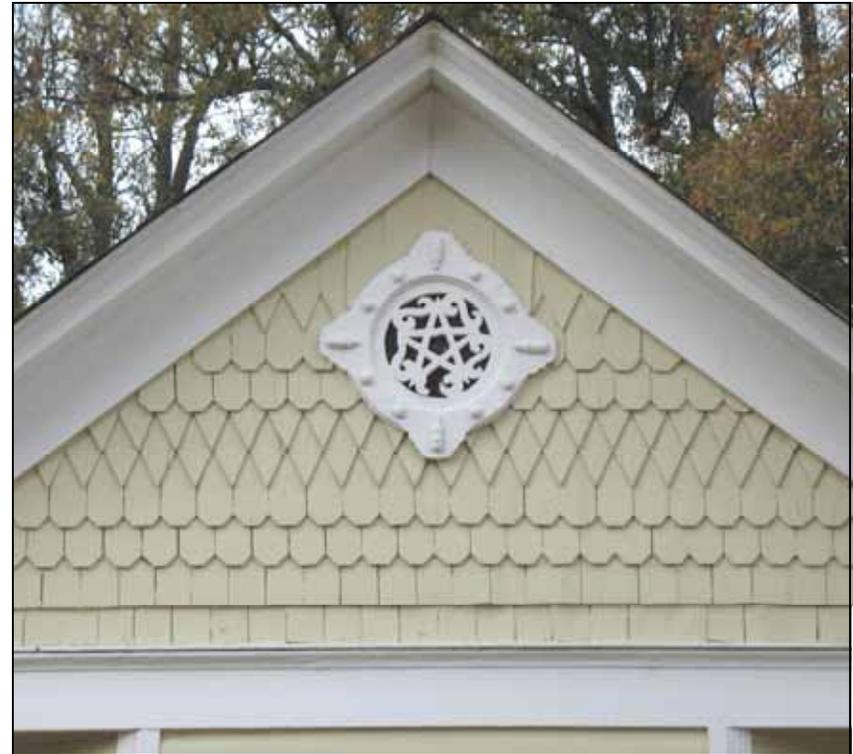
The gable at 204 South Bolivar Avenue uses a combination of wood shingle siding patterns with square, diamond, and Fish Scale to add visual interest to the gable.

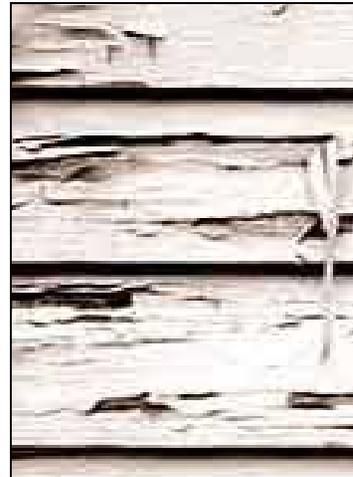
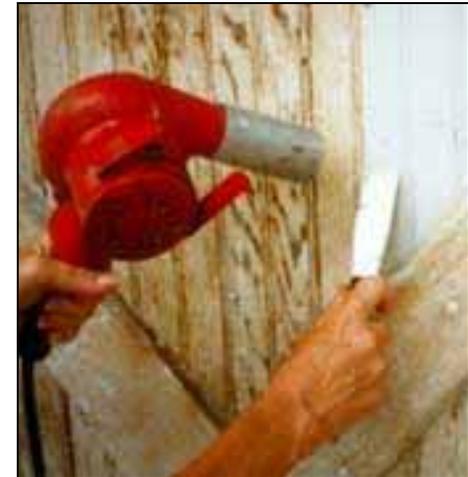
These National Park Service photographs illustrate a painted finish with severe peeling (left) and the use of a electric heat gun (right) to remove a deteriorated paint finish.

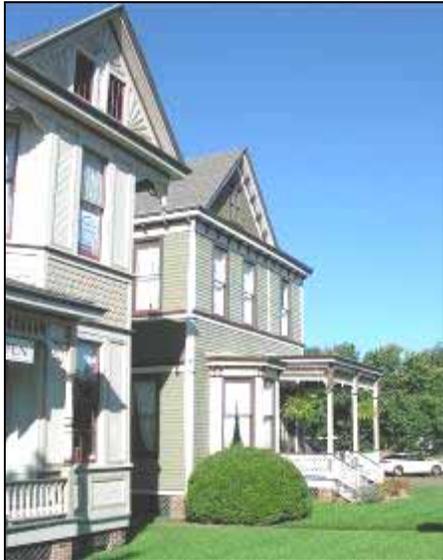
These two Victorian houses in Natchez were restored in the mid-1980s and feature typical late nineteenth-century paint schemes. Both houses were thoroughly scraped, sanded, washed, primed (oil primer), and painted (two finish coats of latex). Both houses have insulated attics but no wall insulation. Their mid-1980s paint jobs still looked good over a decade later.

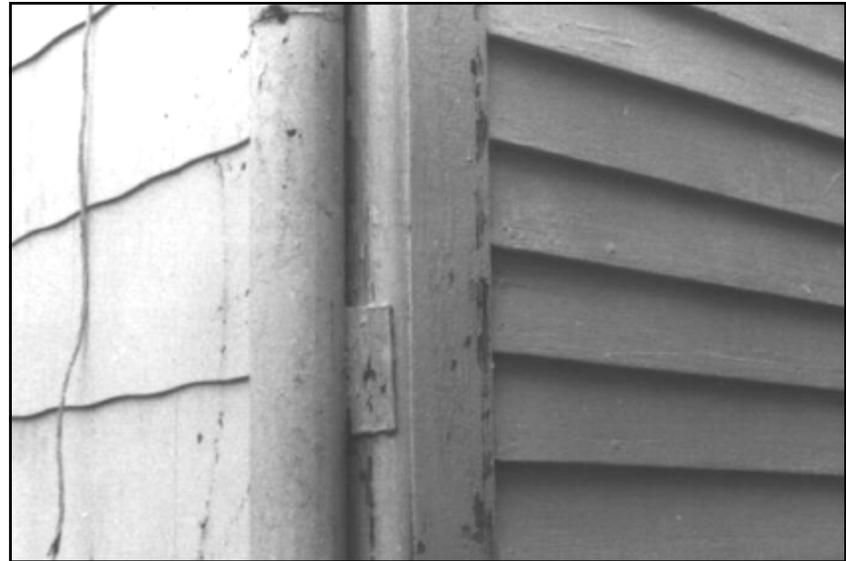
Inappropriate asbestos-shingle siding has been installed over the historic horizontal wood lap siding. The inappropriate siding does not convey the same visual characteristics of the historic wood siding on the right and can obscure moisture and termite damage.

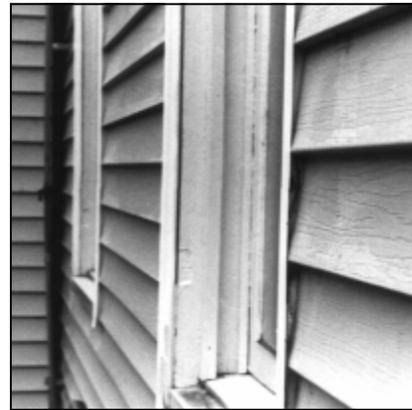
These photographs illustrate how vinyl siding negatively alters the exterior appearance of a historic building. The vinyl siding is nearly flush with the trim around the windows, and J-channels have been installed around the windows to prevent water infiltration behind the siding.

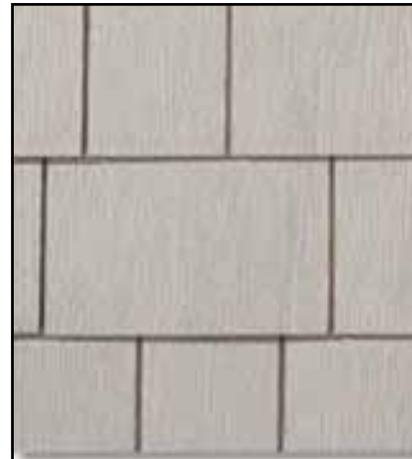
Cement fiber siding is available in a shingle pattern.

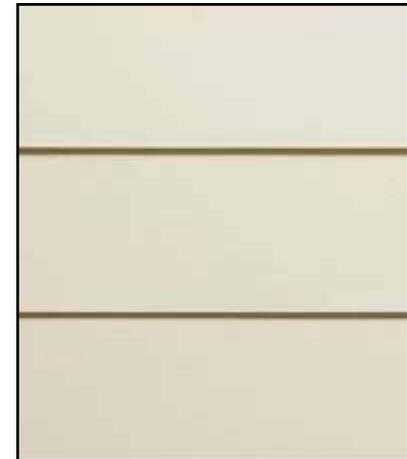
Cement fiber siding is available in lap siding with a smooth or textured finish.

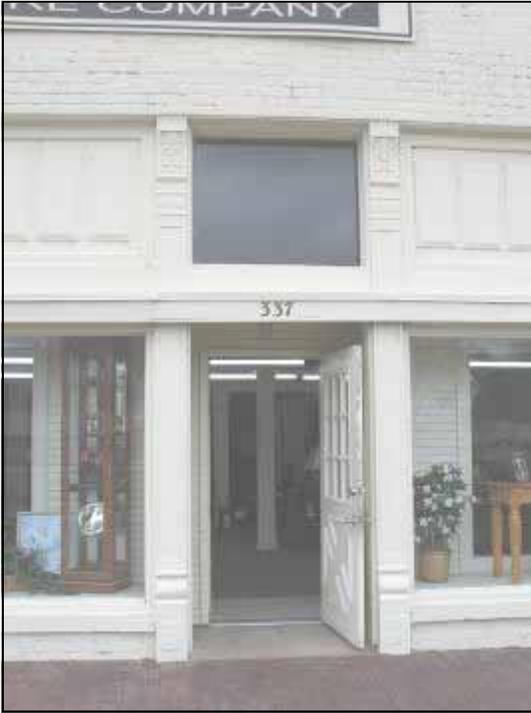
This commercial building in downtown Cleveland still has its original cast iron storefront columns which have decorative bases and capitals. Original columns such as these should be preserved.

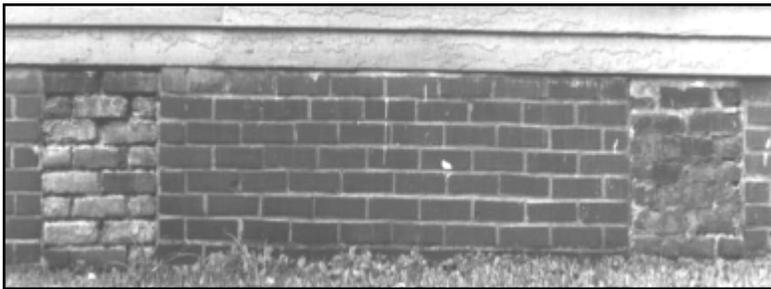
This crawl space enclosure between the original brick piers has altered the historic character of this house and is visually inappropriate. The enclosure also has no vents to allow air circulation beneath the house to prevent the build up of moisture under the house.

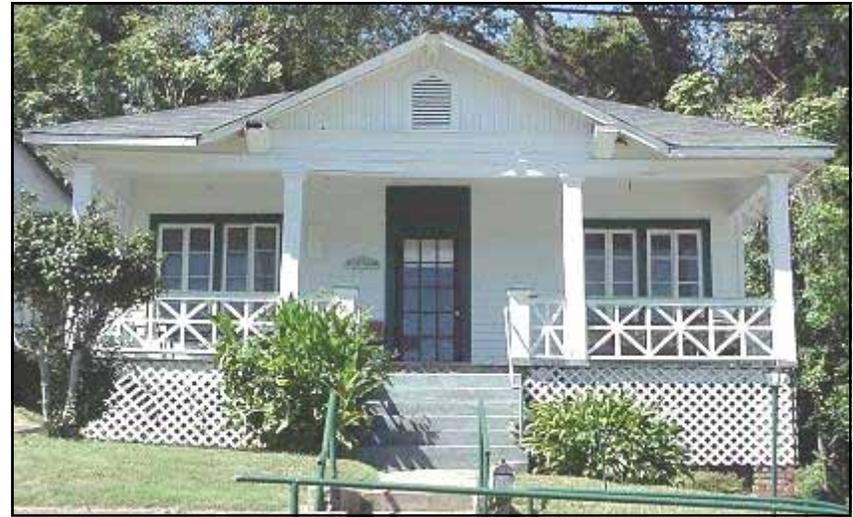
The lattice used to enclose the crawl space beneath this historic house in Natchez is an example of an inappropriately installed enclosure as it overlaps and obscures the brick supporting piers.

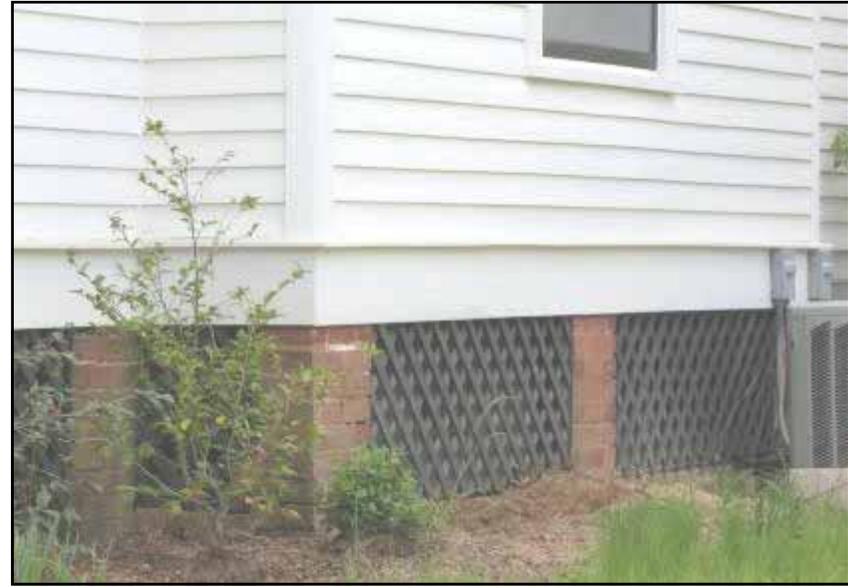
The lattice panels between the brick piers on this historic house appropriately enclose the crawl space area.

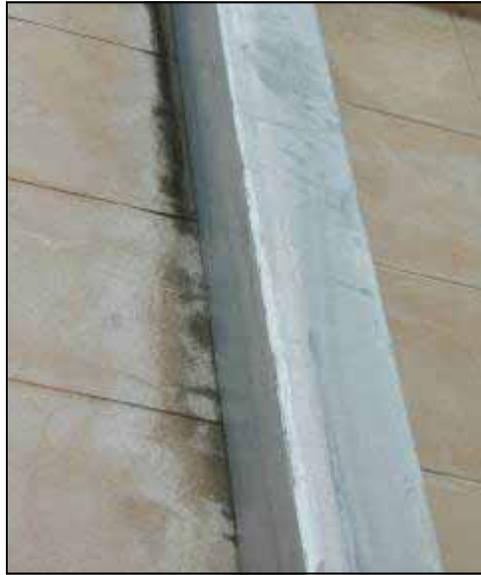
This photograph illustrates moisture problems on the stucco of this commercial building. Rectangular downspouts that lie flat against the building are more likely to cause moisture deterioration than round downspouts.

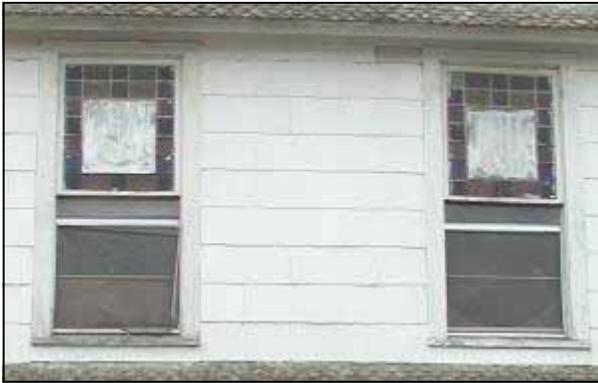
These poorly sized aluminum window screens alter the appearance of these historic windows.

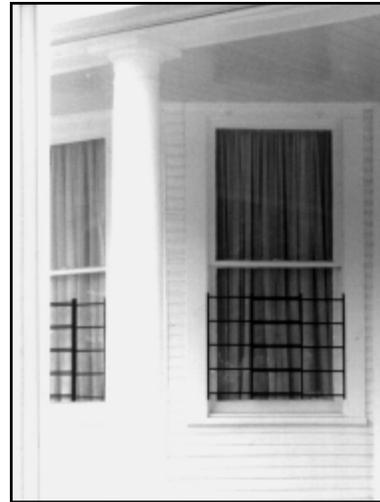
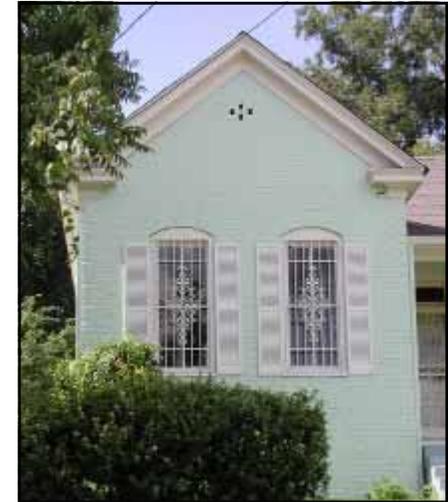
Burglar bars are not appropriate for historic windows, because they change the historic character of the windows.

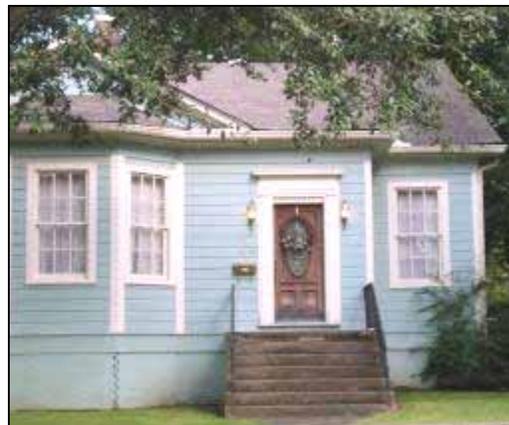
This mass-produced, leaded-glass door is not appropriate for this mid-twentieth-century Colonial Revival cottage, which would have featured a “colonial” paneled door.

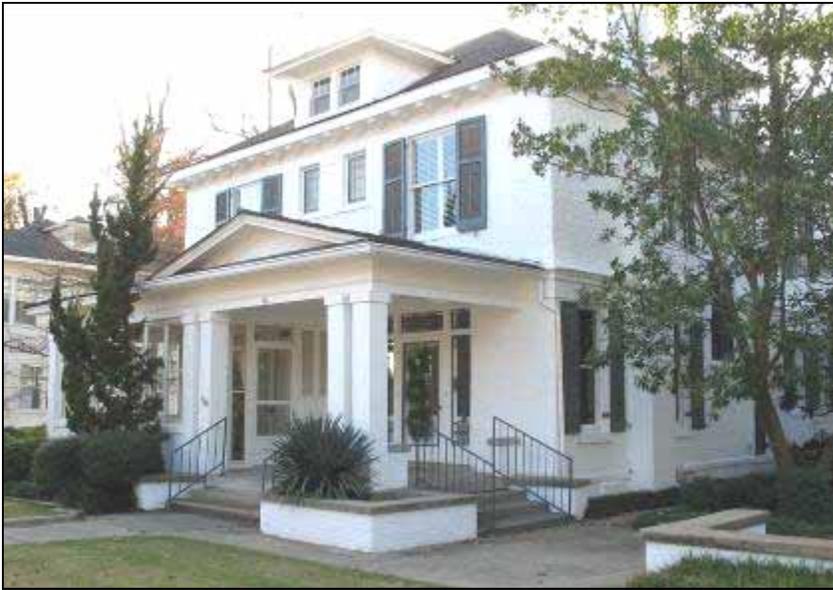
The house at 111 North Victoria Avenue has original louvered wood shutters that are operable and properly hang on shutter hooks.

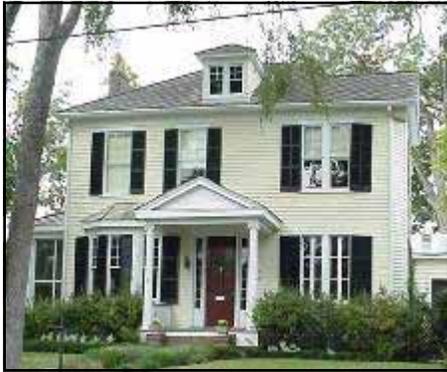
The window shutters of these two houses are original and properly fit the windows. The house on the left illustrates original shutters that are properly sized and hung for paired windows and a bay window.

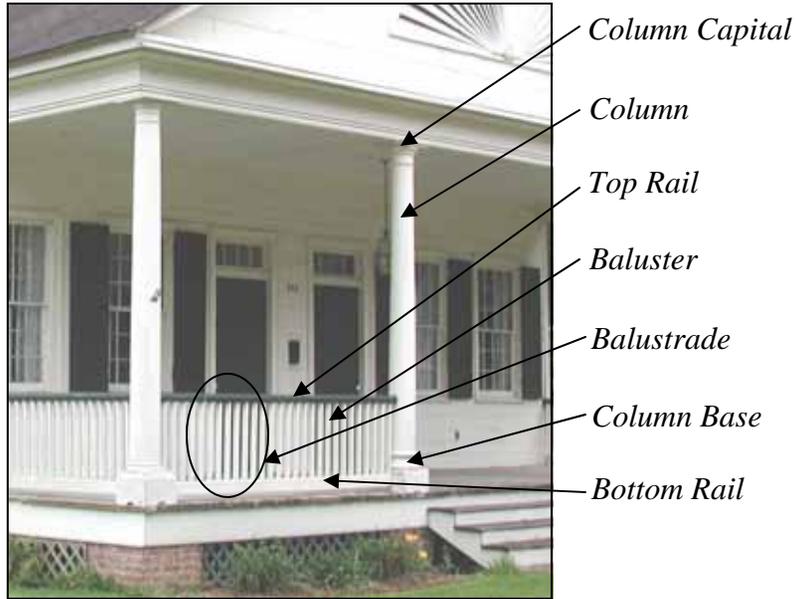
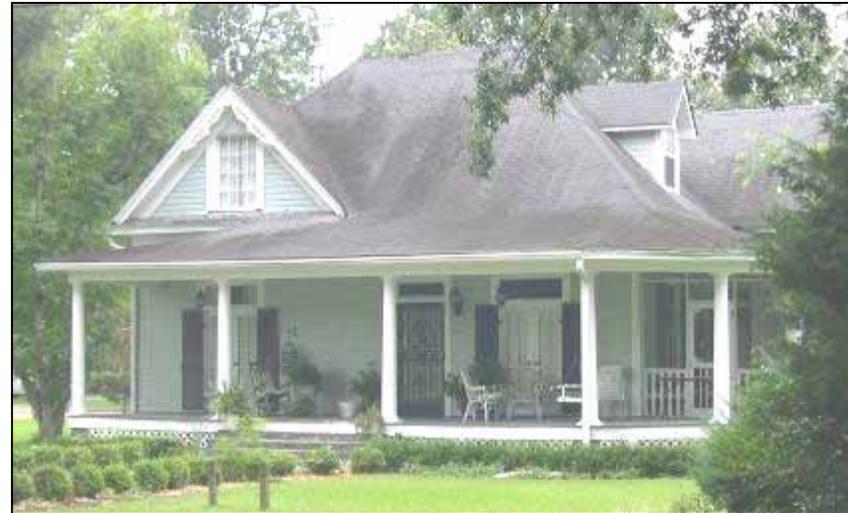
The house at 314 South Bolivar Avenue features a projecting wrap-around porch typical of the Queen Anne style however, the Tuscan columns are more Colonial Revival in detail.

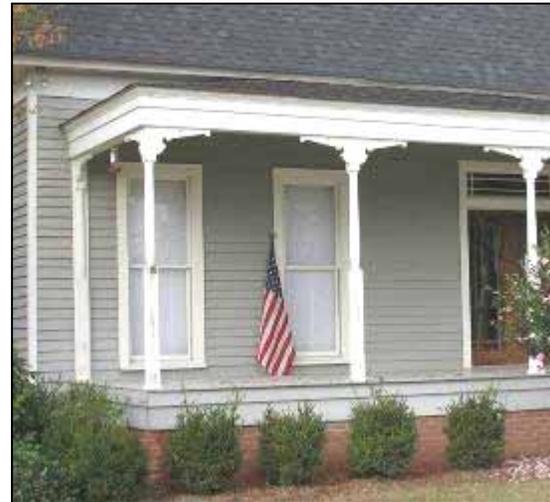
The porch at 209 North Pearman Avenue features typical Queen Anne style details of turned columns and brackets at the top of the columns.

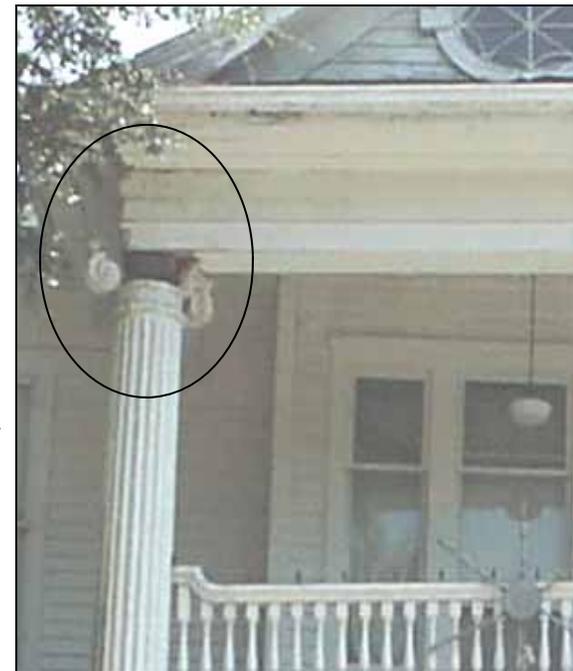
Failure to clean and maintain gutters is the primary cause of porch deterioration such as the damage caused to the column capital.

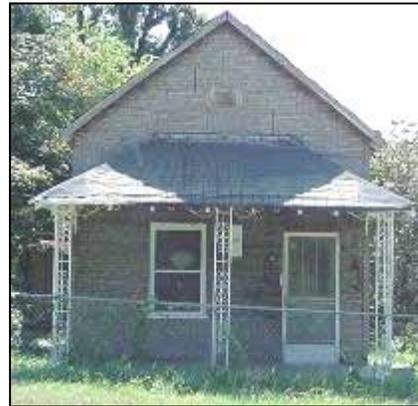
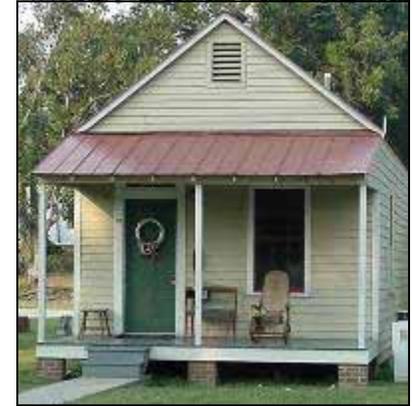
These two Natchez shotgun houses illustrate how changing the porch components alters the historic appearance and integrity of the house. The original columns on the house on the left were replaced with metal trellis columns while the house on the right has wood columns, which are also replacements but are more in keeping with original style of the building.

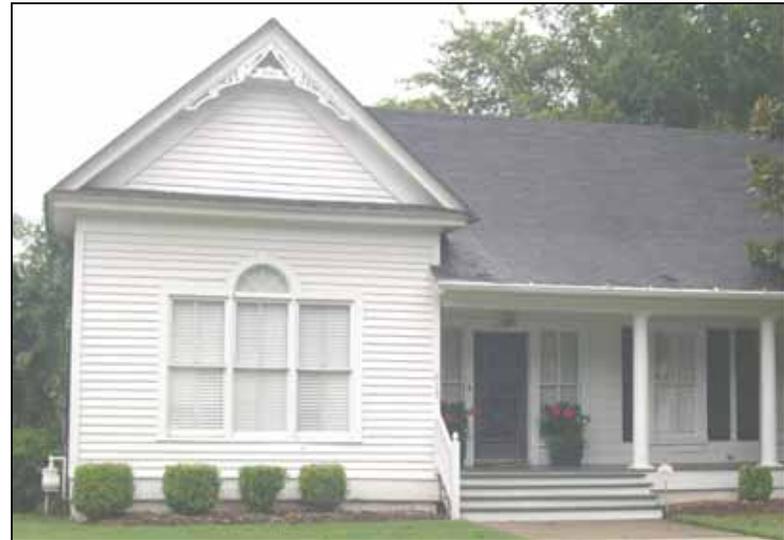
The steps of this Free Classic Queen Anne style house at 213 North Bolivar Avenue are appropriately constructed of wood.

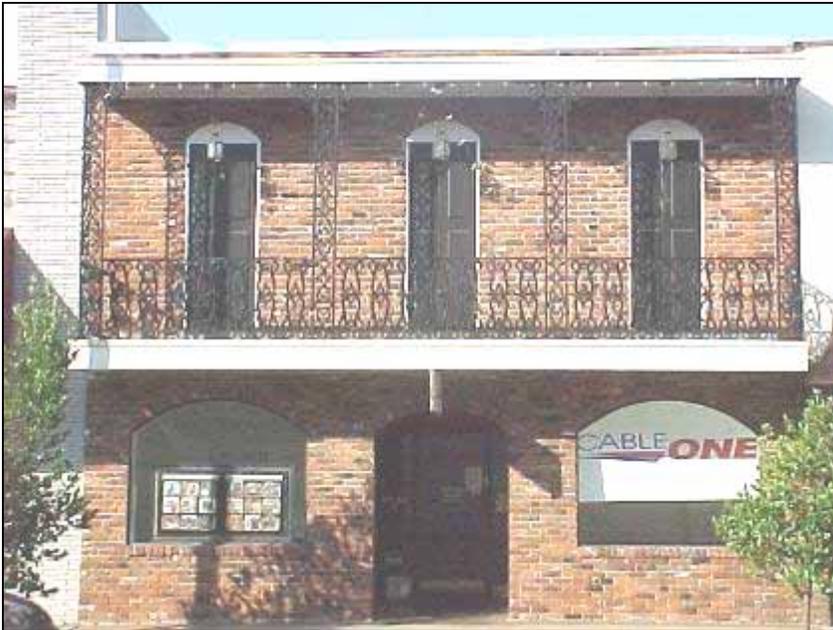
Avoid creating a false historic appearance like this one-story building in Natchez where a faux New Orleans style balcony and doors were added to make it look like a two-story building.

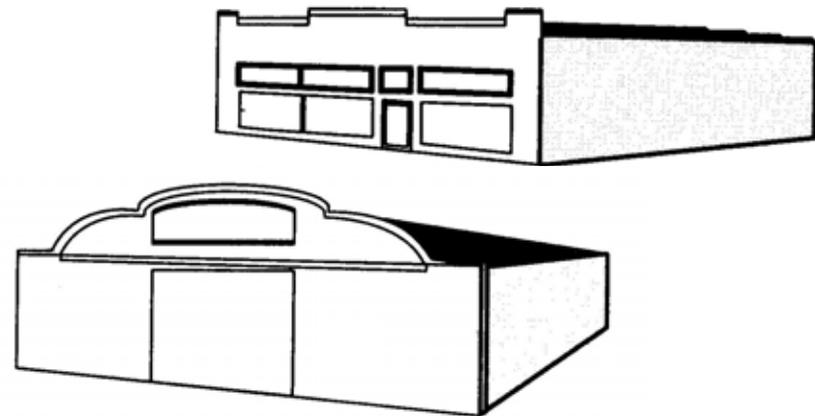
Parapets are a distinguishing feature of rooflines on commercial buildings in the downtown area. Most are very geometric; however a few poises curvilinear shapes.

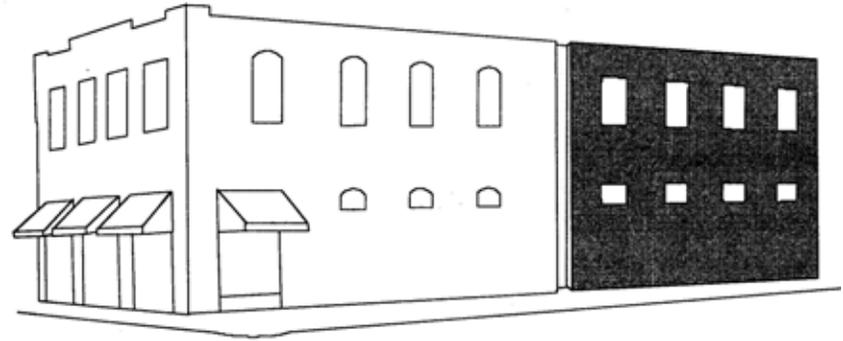
Additions are easily discernable through a small recessed “juncture” and the use of openings which differ in shape while respecting placement and size.

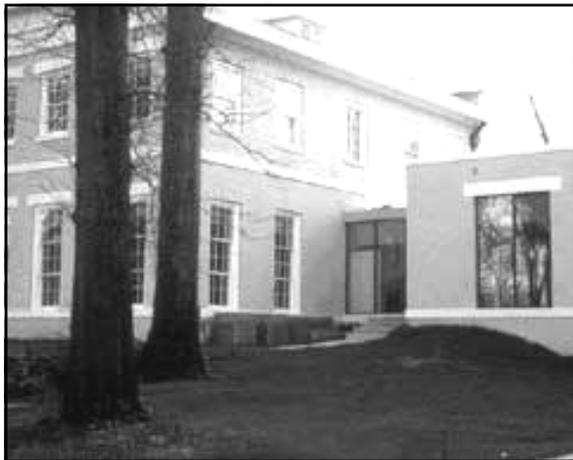
This National Park Service photograph illustrates an appropriate design for a modern addition and a proper method of connecting it to the historic building.

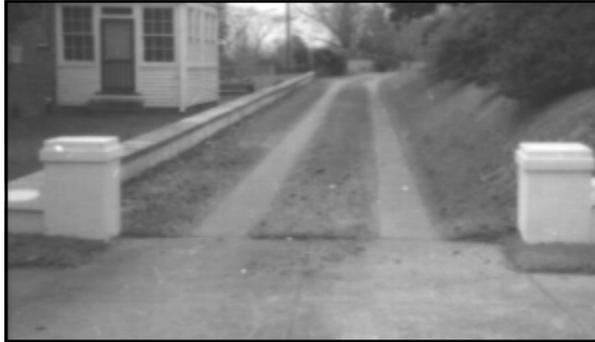
Concrete strips are appropriate for driveways in historic districts. They minimize the impact of driveways on the character of the historic property and its neighborhood.
